# INSPECTION REPORT

**SUNCOR Energy**  
**Firebag 100/6-12-95-6W4M**  
**P2P1 SAGD**

**March 28, 2005**  
**Inspection Report # 2723**

## EQUIPMENT INSPECTION REPORT

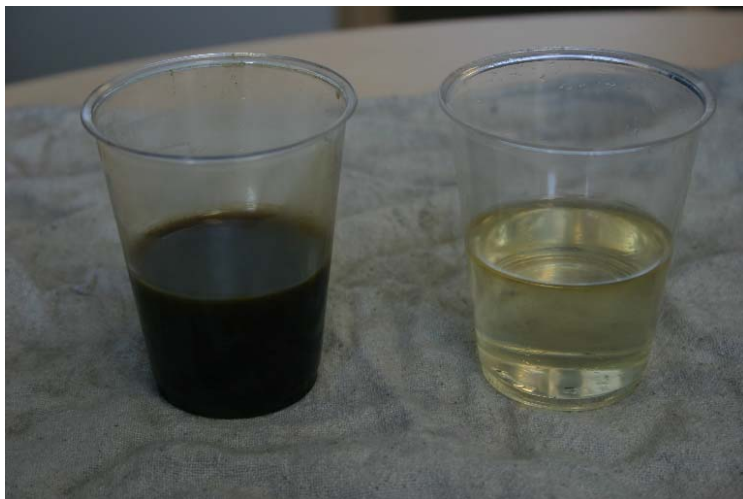
Oil condition: The oil samples taken from the motor were dark in color (please see left cup, picture below). The motor oil was drained and the motor was flushed and filled with fresh, new oil (right cup, picture below). The dielectric strength of the oil before the flush broke down at 18,000 volts and after the flush was good up to 24,000 volts.

The subject motor passed all electrical tests and was drained, flushed, and filled with fresh new oil. This motor has accumulated a total of 58 days in the well at the time of test. This motor is now awaiting schedule for re-installation in the well.
