**PUMP # 2 TEAR DOWN REPORT**  
**Serial # 675UEFGHT101**

**July 13, 2005, Revision-0**

## **Pump Tear Down Report**

## DOWNHOLE TWIN SCREW MULTIPHASE HIGH TEMPERATURE PUMP

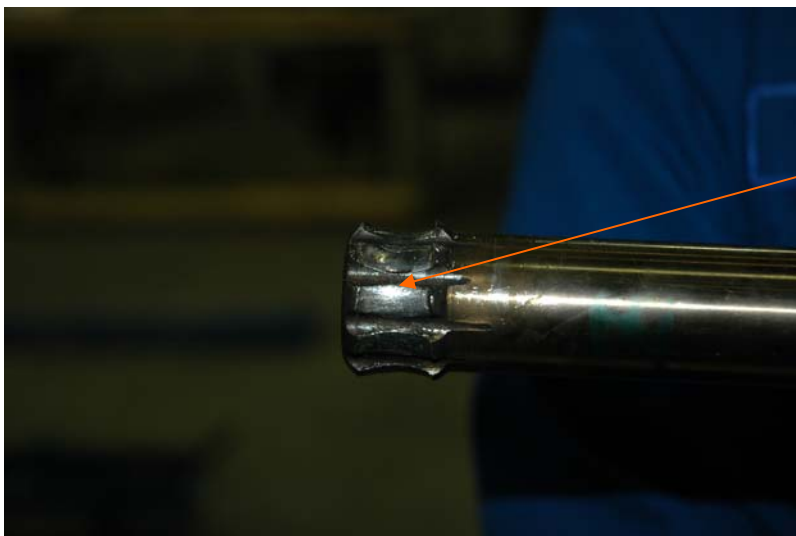
### Angular shaft- Bottom CV Joint

- The angular shaft was removed. The pump was turned and the pump turned, clearly identifying the failure is in the angular shaft module.
- It was then decided to tear down the angular shaft module. At the bottom of the angular shaft the bullet area of the CV joint was completely worn out. The thrust seat where the ball is located was also chipped at the bottom.

Bottom Bullet grooves  
damaged completely.  
No positive drive.

The assembly procedure was revisited. It is rewritten now. Stoppers are being provided in the new design so that there is no chance of error in future regardless of who will assemble it. Training has now been provided to all personnel on the assembly so that this will not repeat this error any more. Apart from this change, all refurbished pumps will have the larger angular shaft installed as we are manufacturing multiples of the new design for the larger pump which are being manufactured for Suncor.

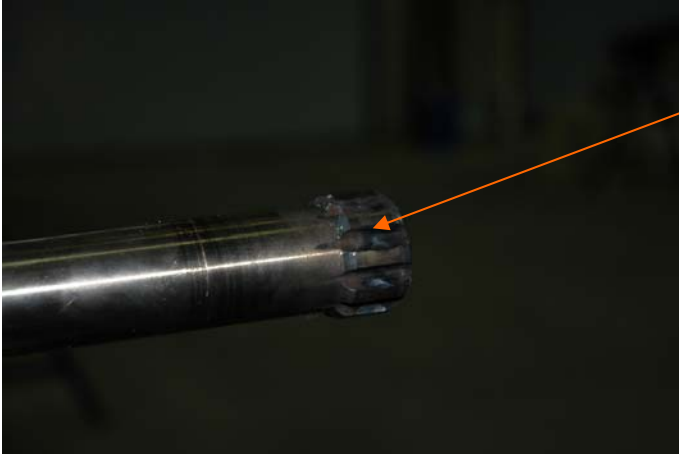
### Angular shaft-Top CV joint

Top CV Joint. There are some wear but very minor

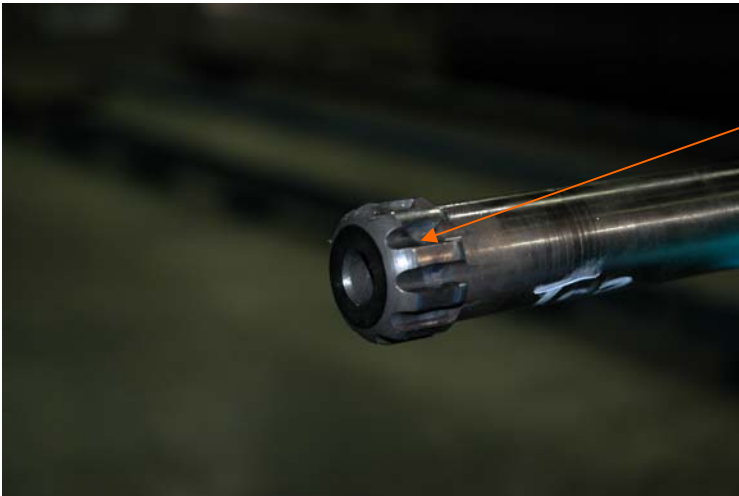
### Angular shaft-another view- Top

Same piece giving a side view. Minimal wear.

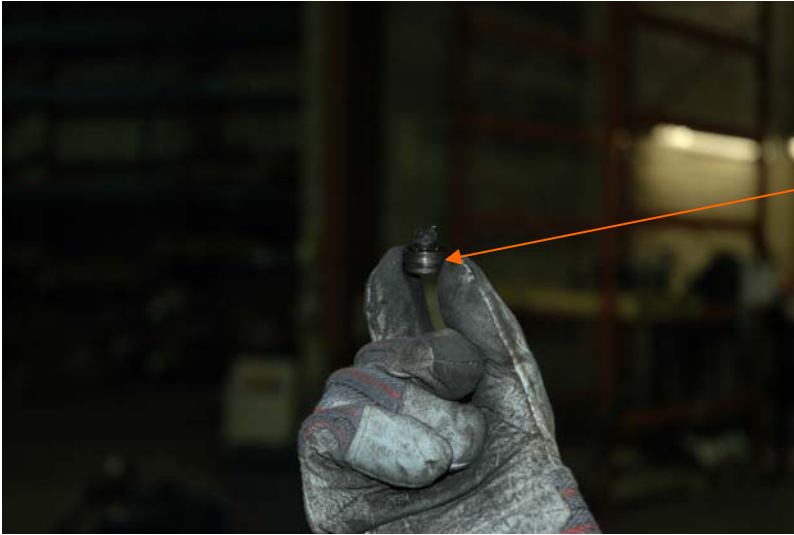
Angular shaft Ball seat- bottom

Bottom Ball  
seat chipped

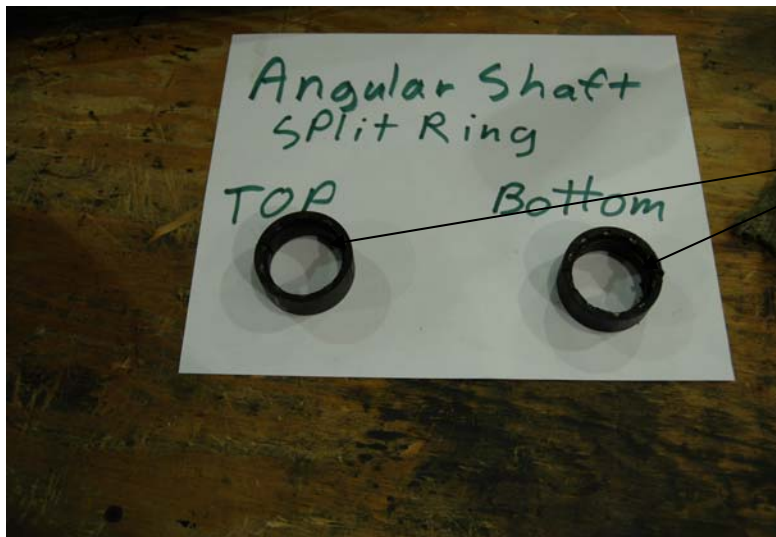
## Split rings –both top and bottom

- On closer examination we found that the split rings when assembled at both ends were pushed in during assembly. This obstructed the free movement of the angular shaft while rotating. The split rings were gouged in by the bullets. The procedure of assembly was reviewed. It was concluded that the angular shaft was not assembled correctly.

Split rings.  
Top and  
bottom

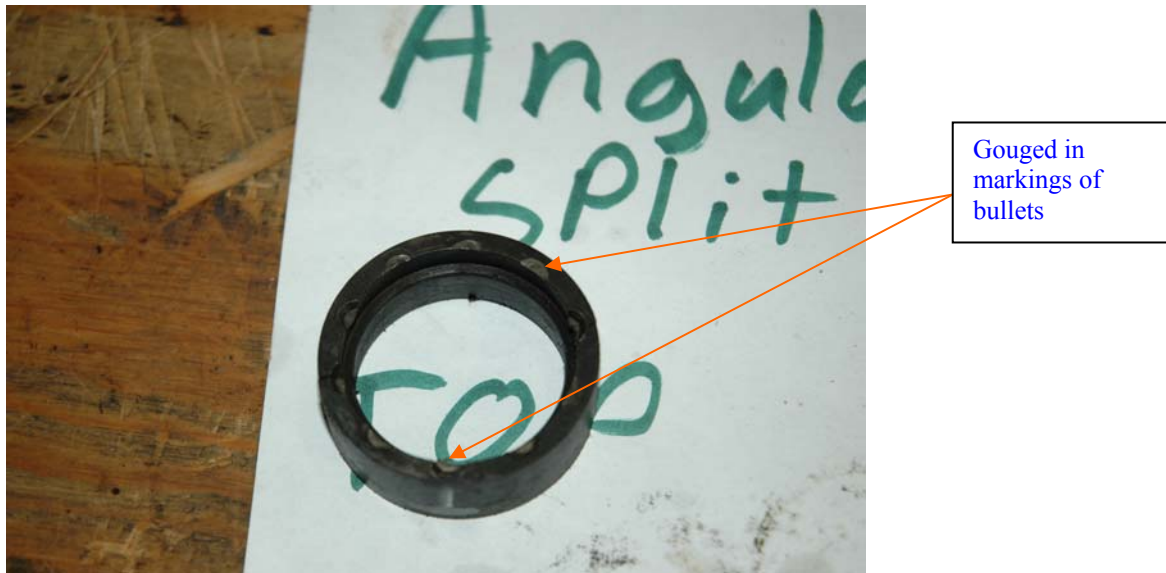
Top split ring of angular shaft module

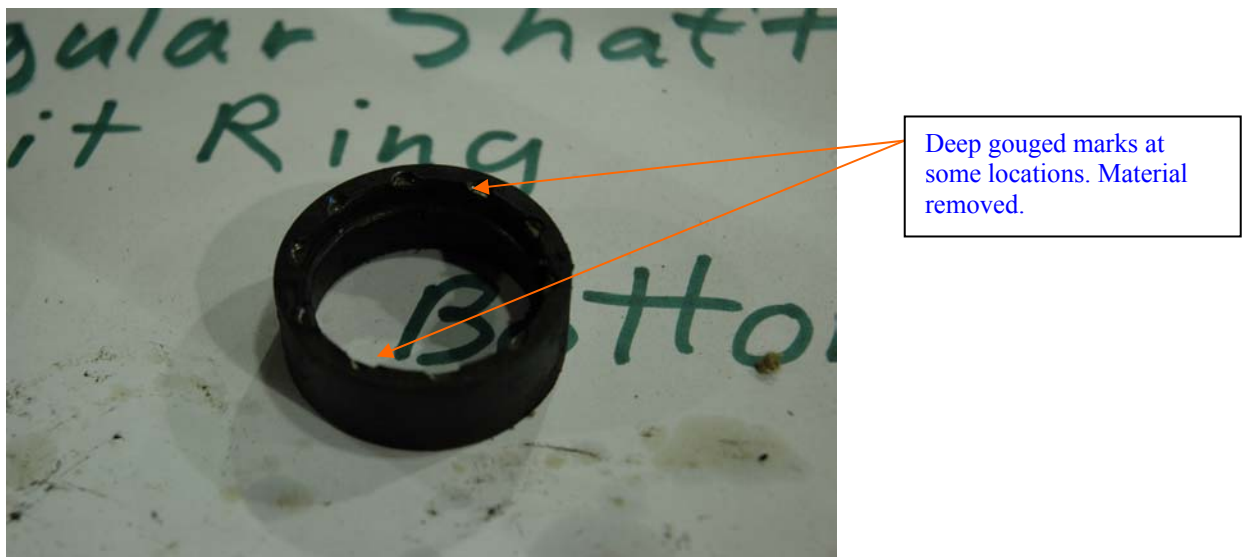
Bottom Split ring of angular shaft module

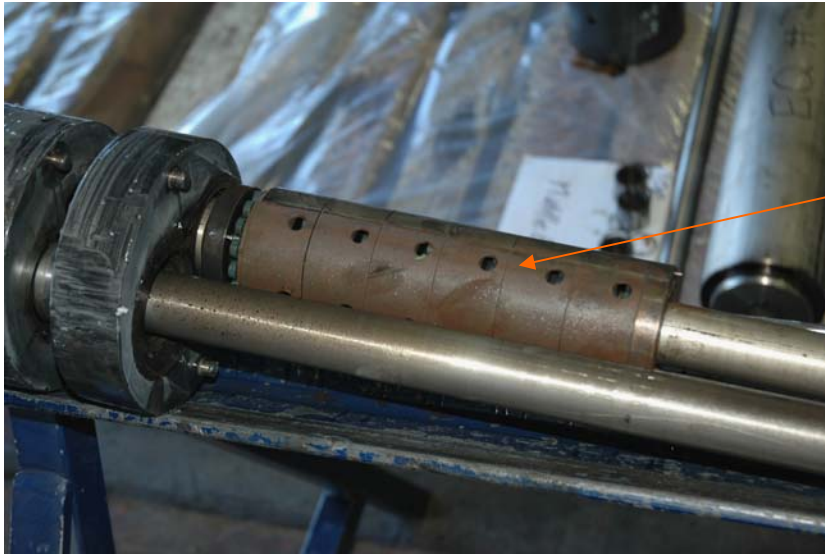
Gate Thrust  
Bearing

Gate thrust Bearing stack. In excellent condition

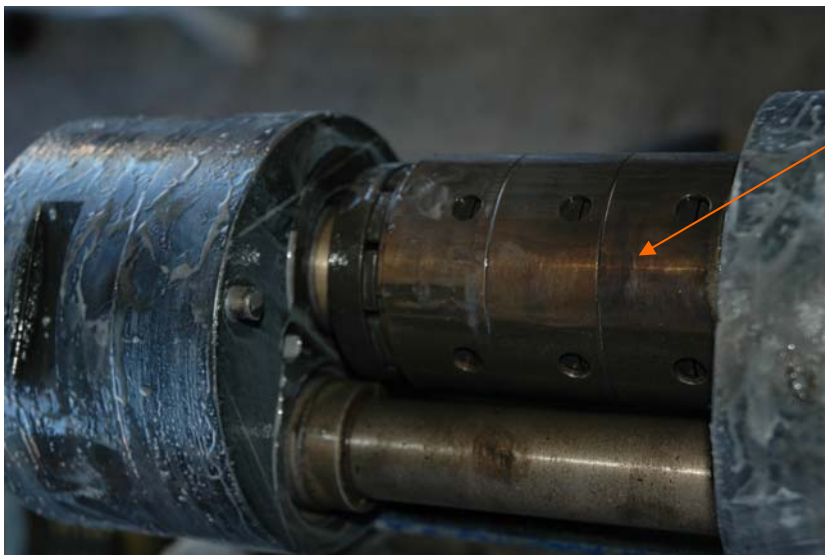
Main thrust  
bearing

Main Thrust Bearing stack in excellent condition

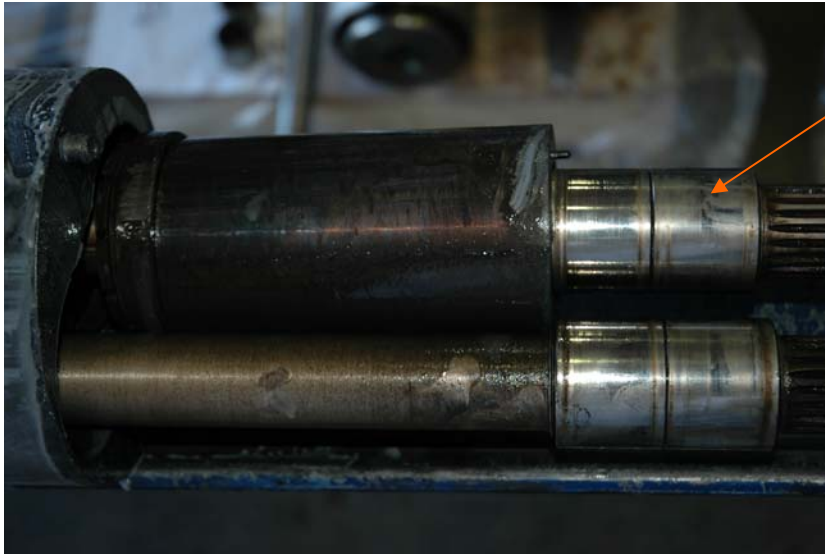
Radial  
bearings

Radial Bearing of thrust section in good condition

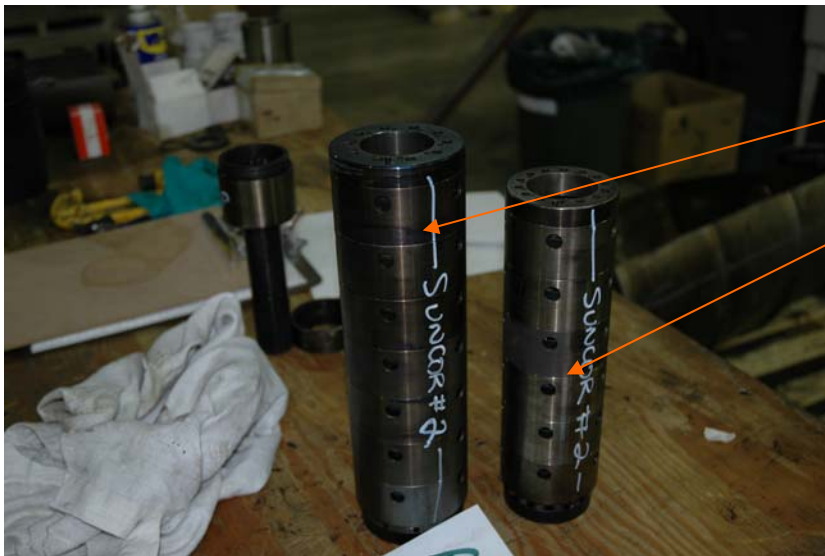
Thrust Bearing stack after QC. Excellent condition. 100 % reusable

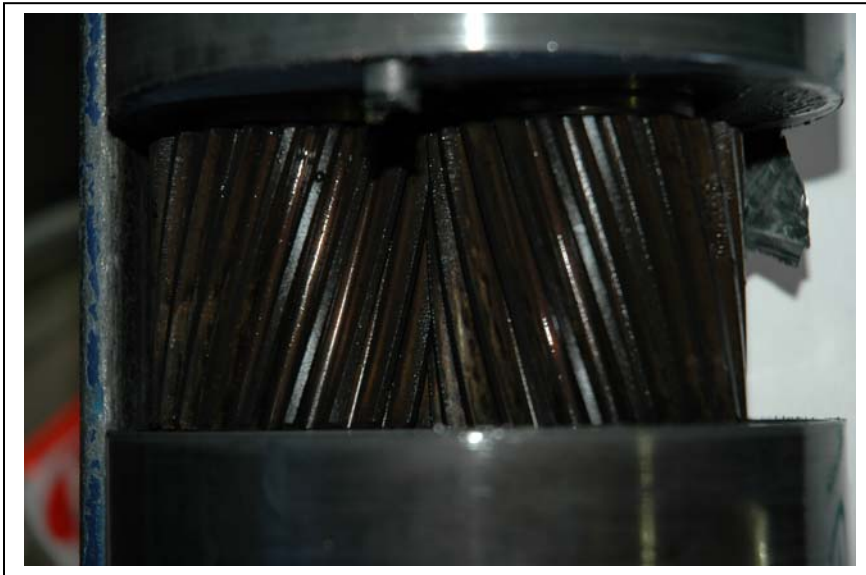
Timing Gears in excellent condition

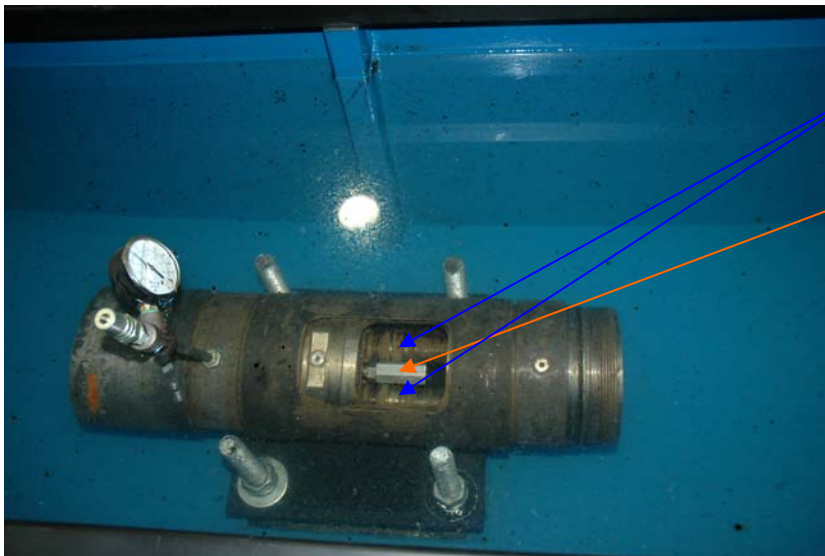
Intake section tested for days for resealing in water tank. Mechanical Seals and check valves in very good condition.

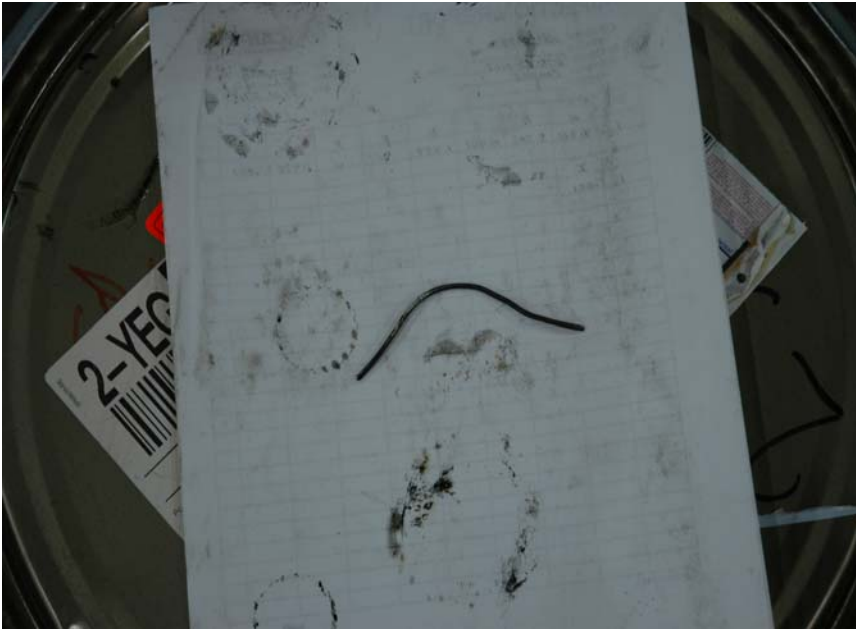
Foreign material which was provided to us by Suncor which came up with the pump. This has been given to Suncor for identification. No identification has been done at the time of preparing this report.

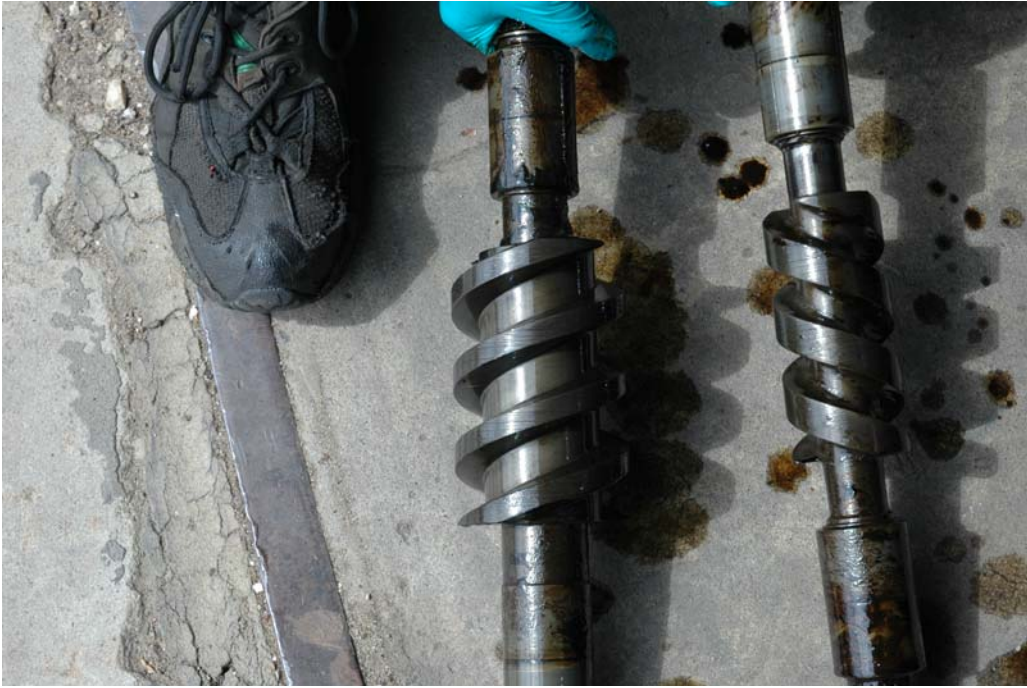
A pair of screw shown with some deep grooves probably indicating some solid material that tried to enter the pump.
