**SUNCOR 675 ESTSP R1
PUMP # 1 TEAR DOWN REPORT
Serial # 675UEFGHT100**

April 28, 2005 Revision-1

Pump Tear Down Report

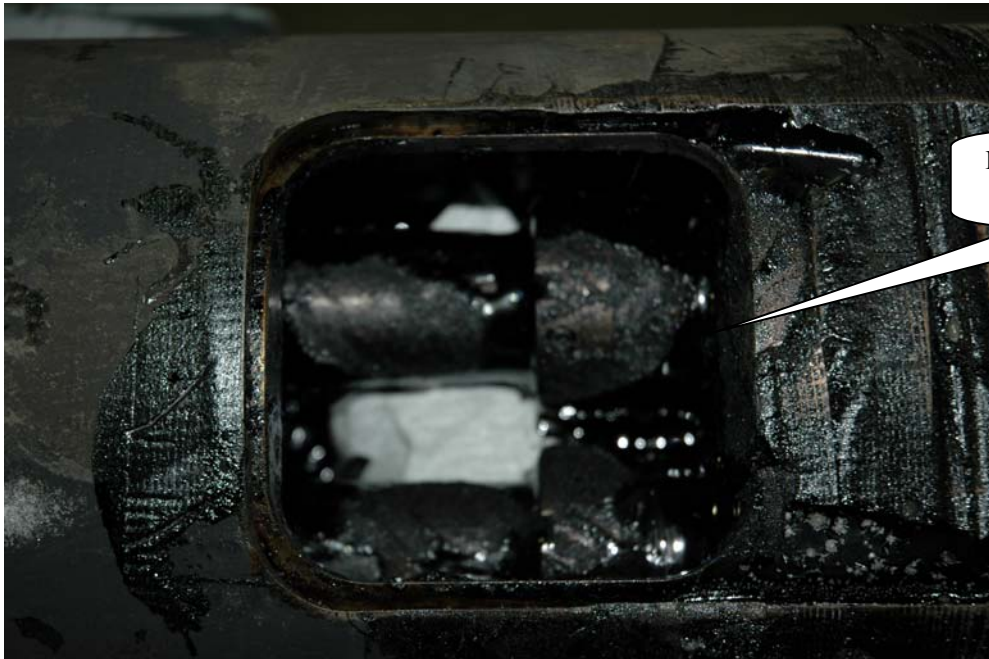
- We noticed that one of the mechanical seals at the intake was leaking as it showed bubbles.
- The check valve was not closing back and the air was leaking through the check valve at the intake too.

Pump Intake showing the mechanical seals

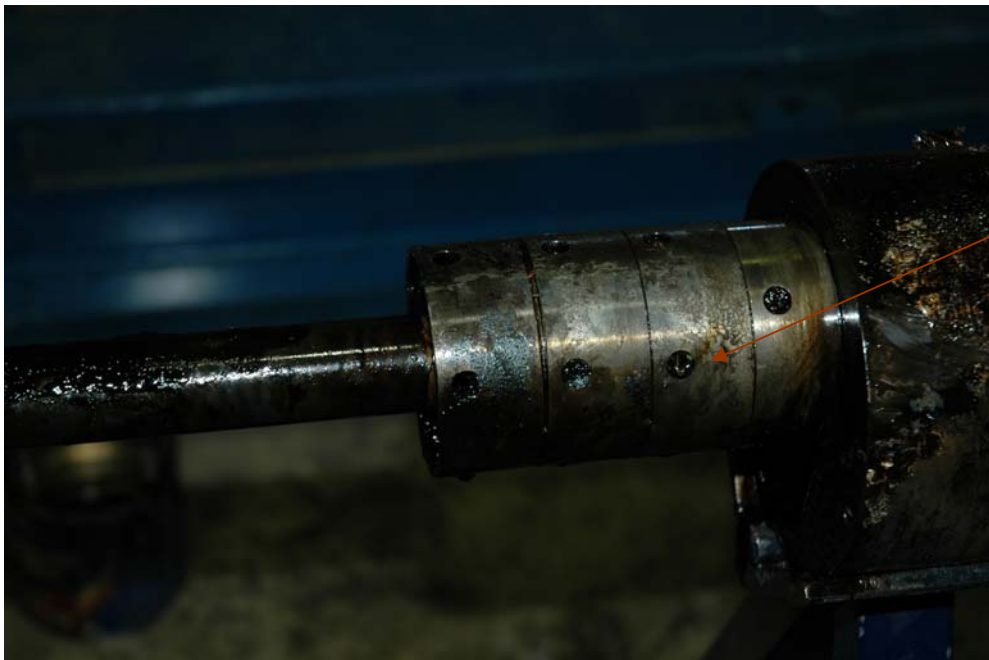
Main thrust bearings stack

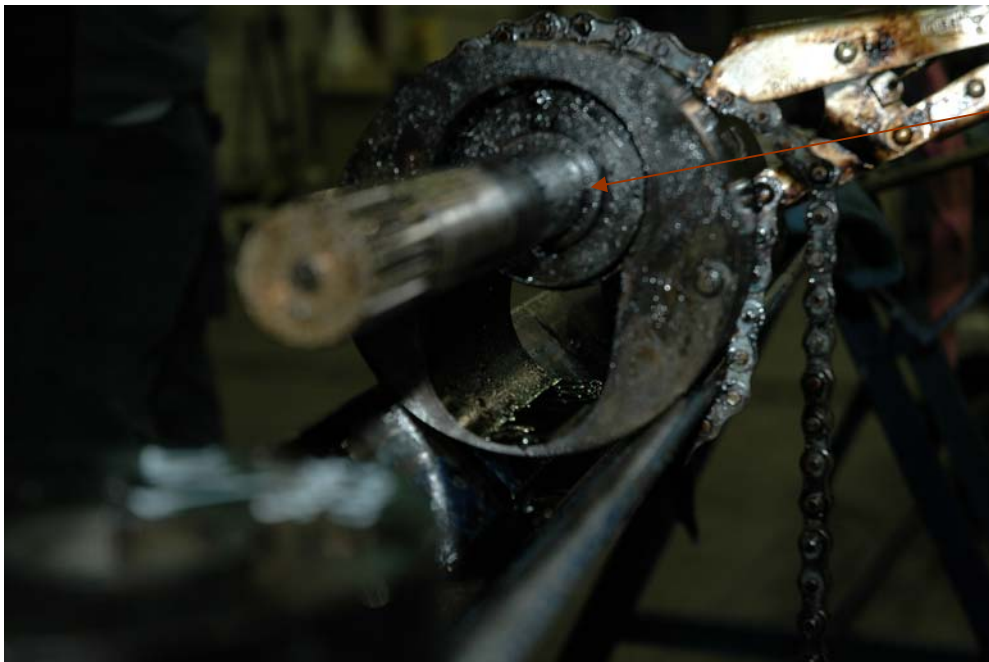
- We had to grind off some metal pieces to open the thrust section. The shaft at the thrust section was sheared. It was sheared due to intense heat at the thrust. All the thrust bearings were completely damaged and welded together. The other shaft at the thrust section, though turned black did not shear.

Main thrust bearings

Main Thrust bearing shaft

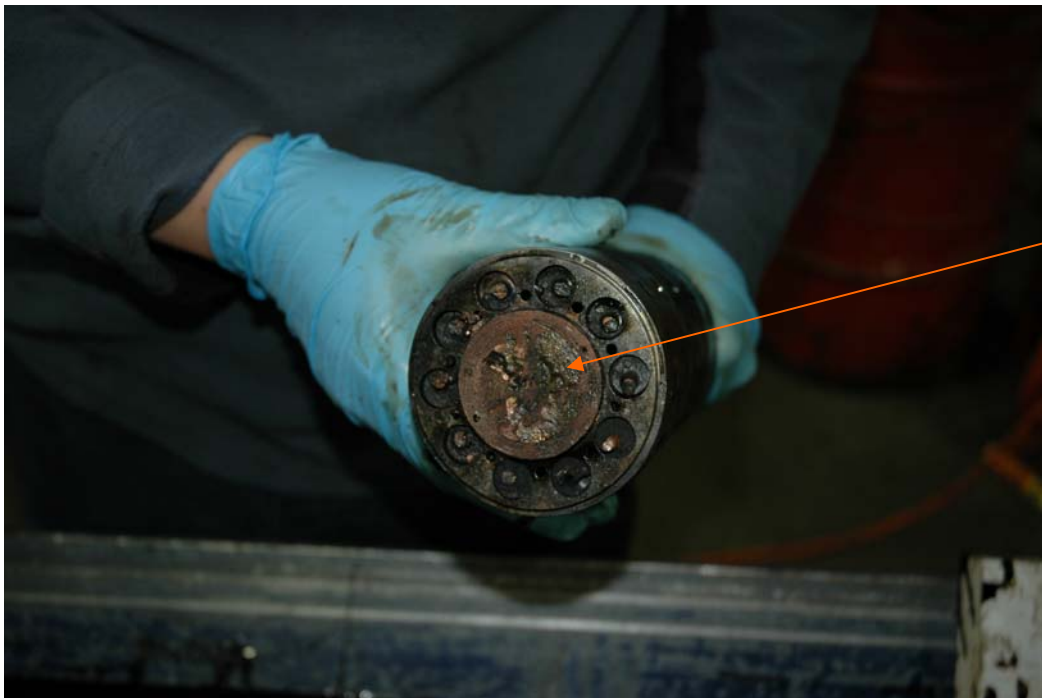
Main shaft sheared and welded on to the main thrust

Main shaft Sheared with thrust bearings damaged

6. Provide provisions of extra cooling areas on the thrust sections instead of using Aluminum and or Copper sheets to reduce thermos type heat containment at the thrust areas. The present failed pump had aluminum sheets rolled around the main thrust and gate thrust to conduct heat to the external shroud. New designs could have slots for direct contact with the well bore fluid. At the present time we have already changed it to copper for better heat dissipation.

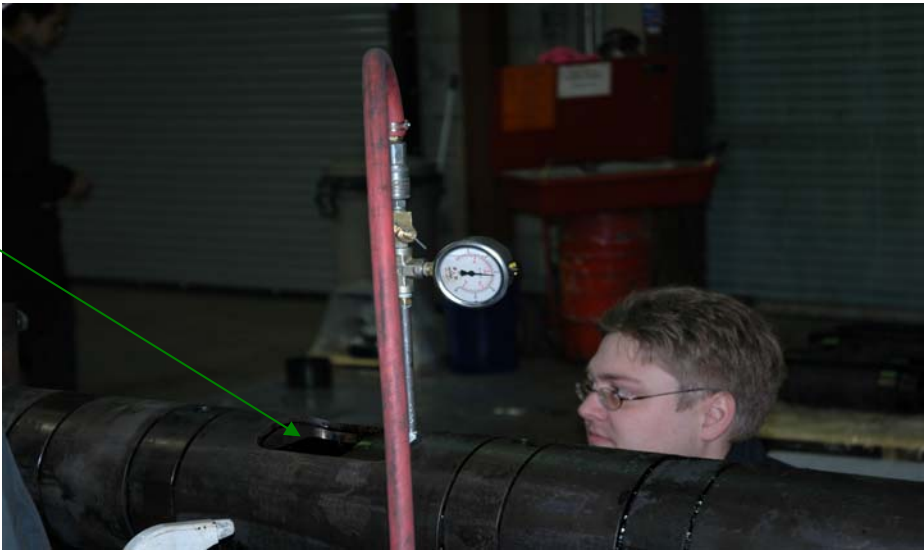
Pressure Test
of the barrier
section

Pressure Testing of the seals

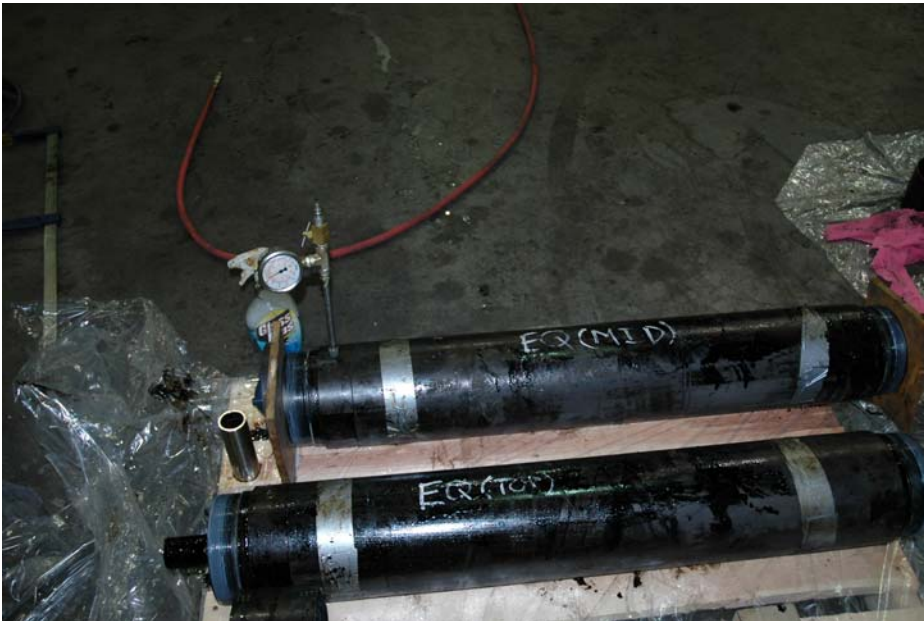
- The equalizers were removed and checked independently for leaks with pressure test and did not show any leaks.
- The bottom mechanical seal with the bottom equalizer was independently tested at 20 psig for leaks and did not show any leaks at all. This shows the bottom seal is in good condition.

Independent Pressure Testing of Equalizers

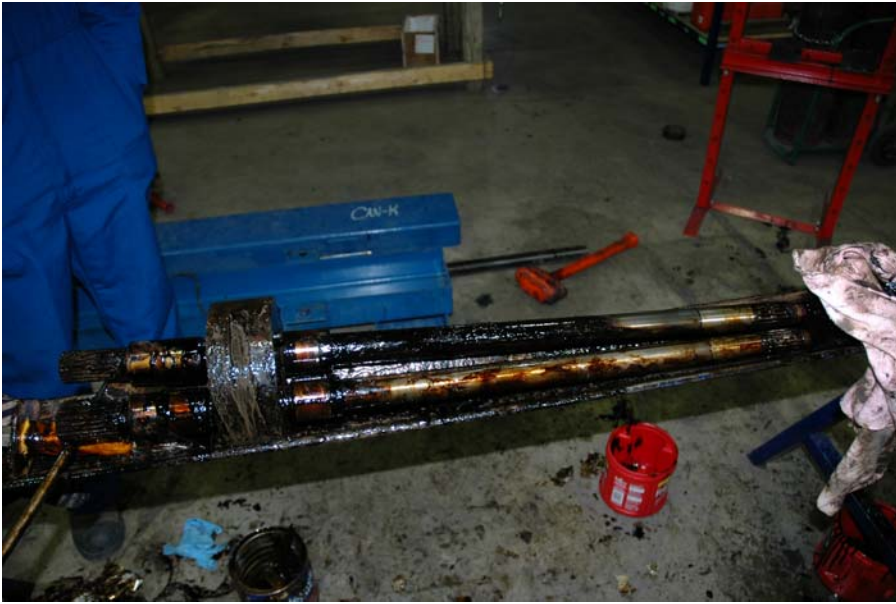
- The gate thrust section was removed. It was turning fine but filled with crude oil. The thrust bearings were completely filled with crude oil and on initial cleaning did not show any damage.

Gate Thrust Shafts

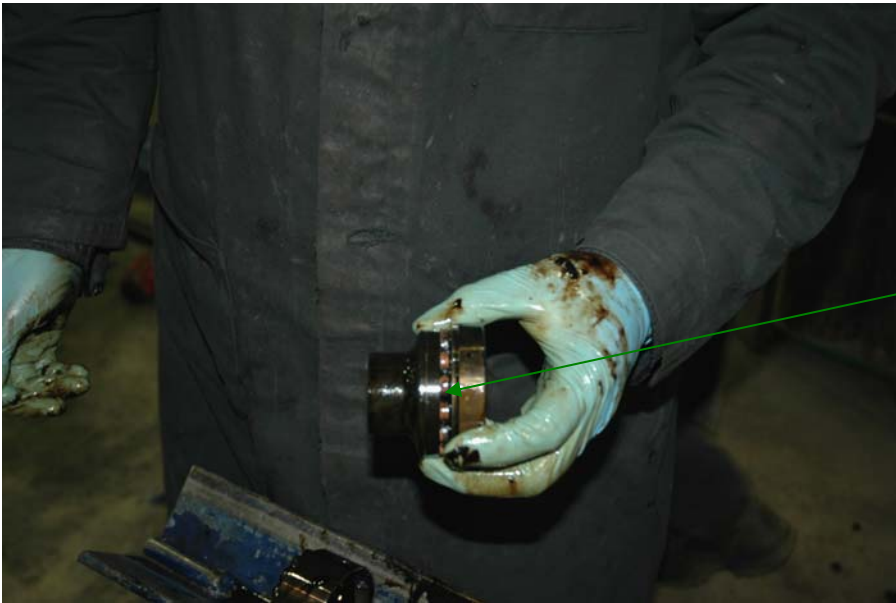
Gate Thrust pad and runner
(one stage of the stack)

Gate thrust

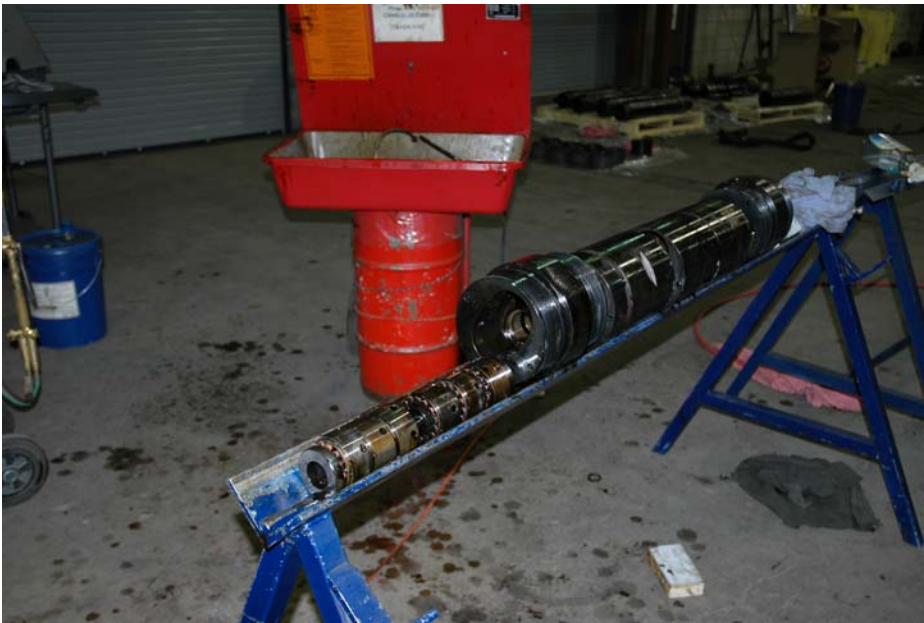
Gate Thrust Module disassembled

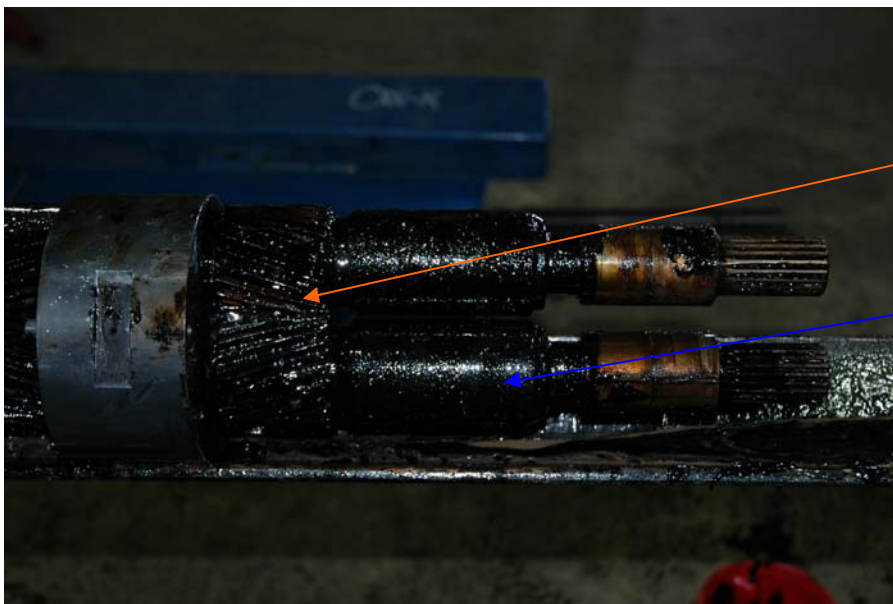
Timing gears- one pair shown. Filled with crude oil. No visible damage.

Lock Nuts
(No visible damage)

Timing Gears

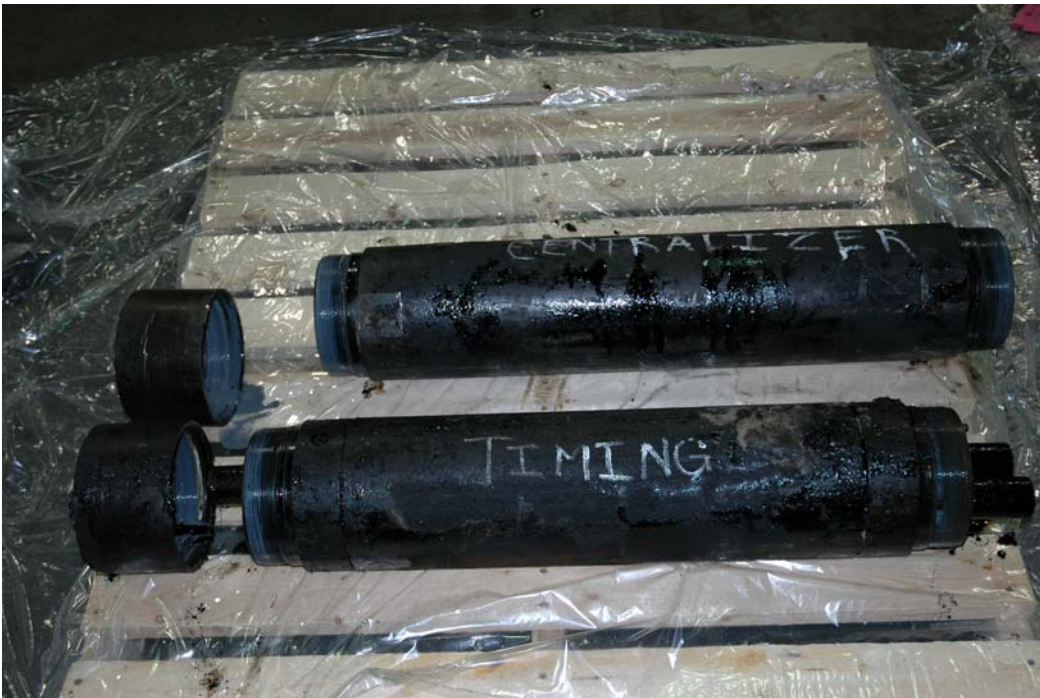
Centralizer & Timing Gears as Modules ready for disassembly

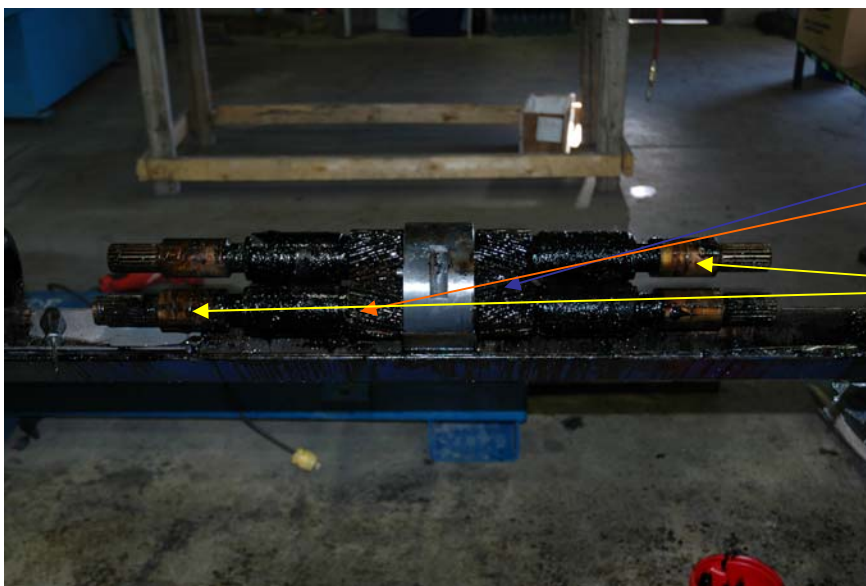
Timing gears-
two pairs

Tungsten
bearings all in
good
condition

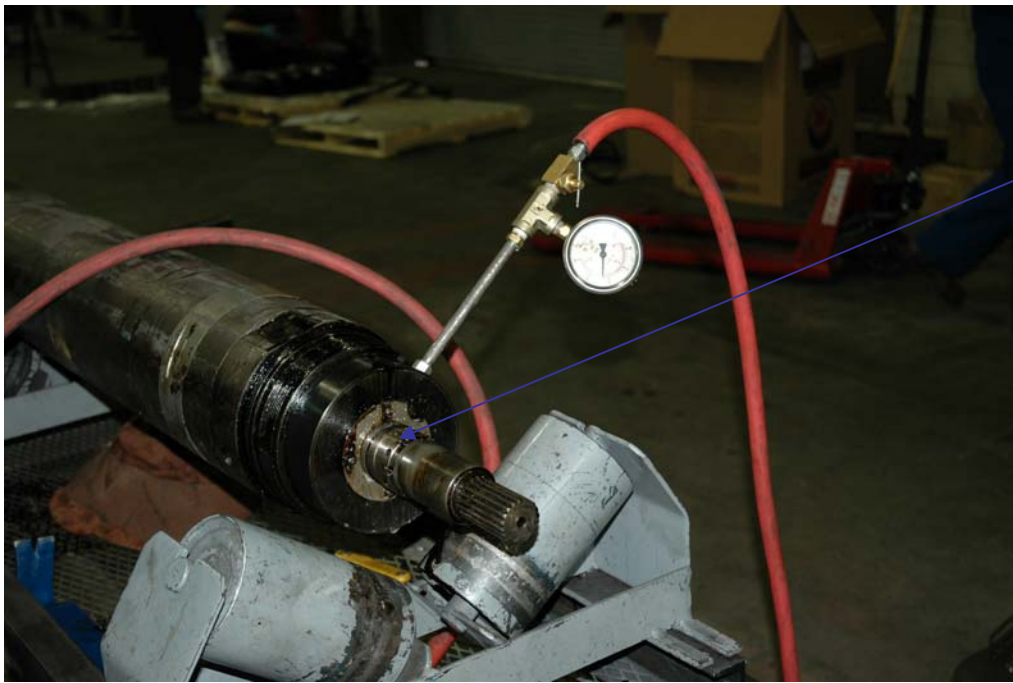
Bottom
mechanical
seal pressure
testing. No
leaks

Bottom mechanical seal being pressure tested. No Leaks. Similar design to the top mechanical seals.

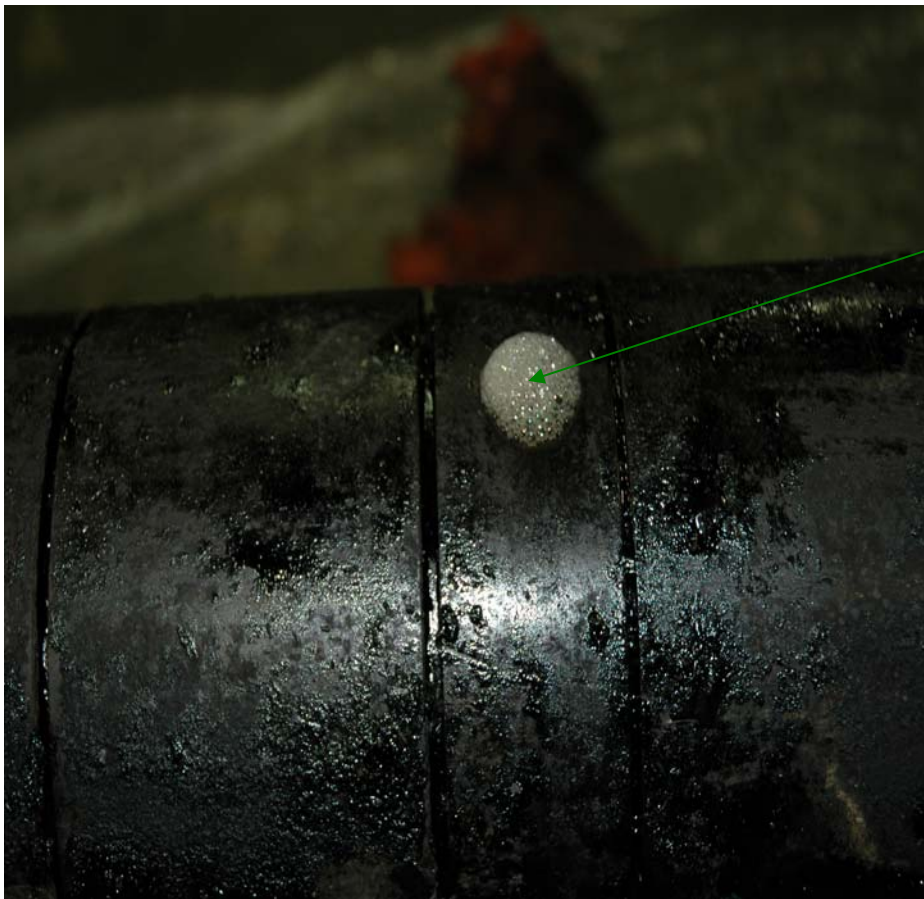
- Two ORB ports directly above the thrust bearings were showing bubbles confirming leaks.
- The bottom seal did not have any leaks at all, though the bottom and top mechanical seal design are of the same type in design.

Leak on the
ORB on the
thrust

ORB pressure test on the thrust module. Showing Leaks on the ORB.

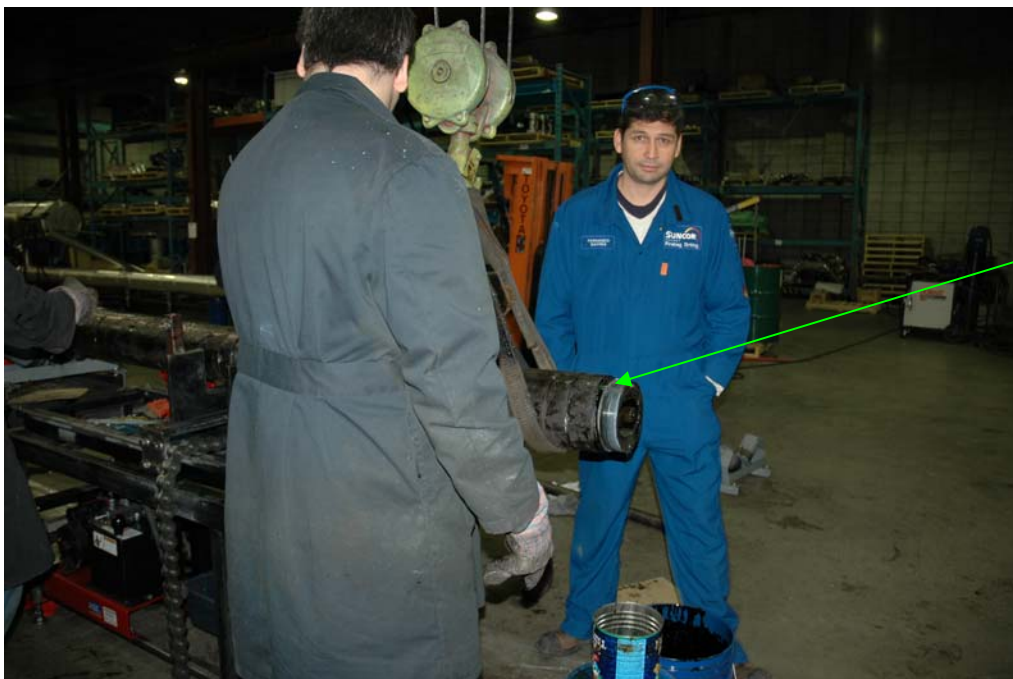
Areas of clean
threads
indicating no
leaks between
faces

All thread connections between faces showed no leaks. Original thread dope is shown.

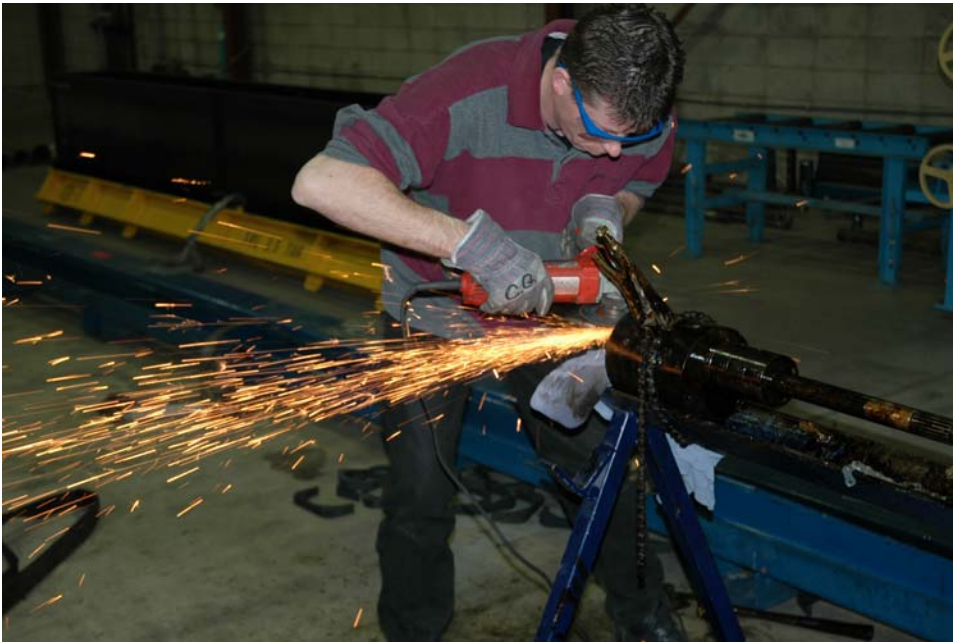
Cutting of metal pieces to remove main thrust bearings which are welded on due to high heat.

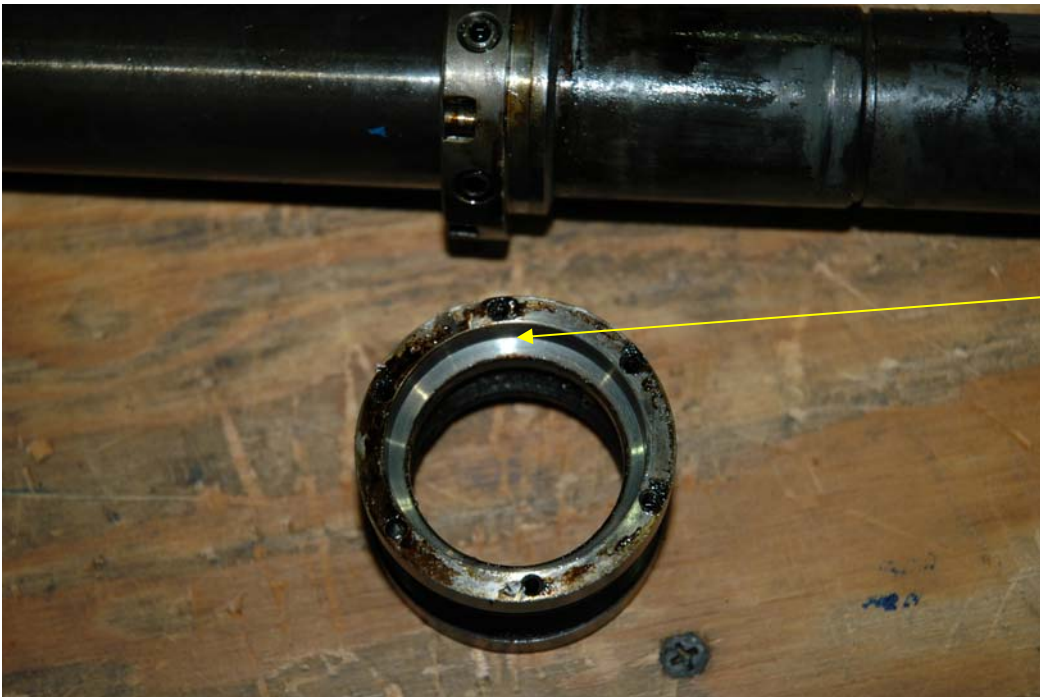
- The mechanical seals were removed from the intake side. The path with graphalloy which is on the path of the shaft and the seal was clean and was not damaged. The faces were not cracked. The bellows of the mechanical seal did not show any leak when pressure tested meaning the bellows are good. The stationary seat when

Graphalloy
removed and
face looks
clean

Mechanical seal (rotating) with graphalloy removed.

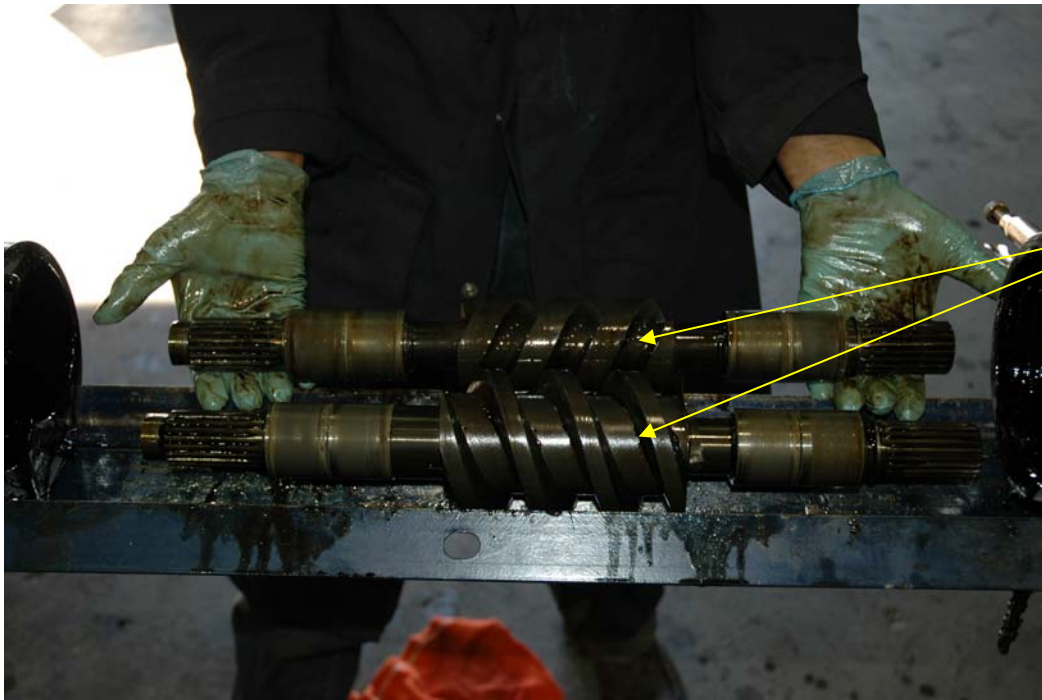
- The first stage was dismantled to observe if there was any damage since the thrust was damaged. We noticed that the main screw ran on the gate screw, this was observed with curvature lines on the flanks of both the screws. The screws were damaged.

Gate and
main screws

Gate and Main screws after cleaning

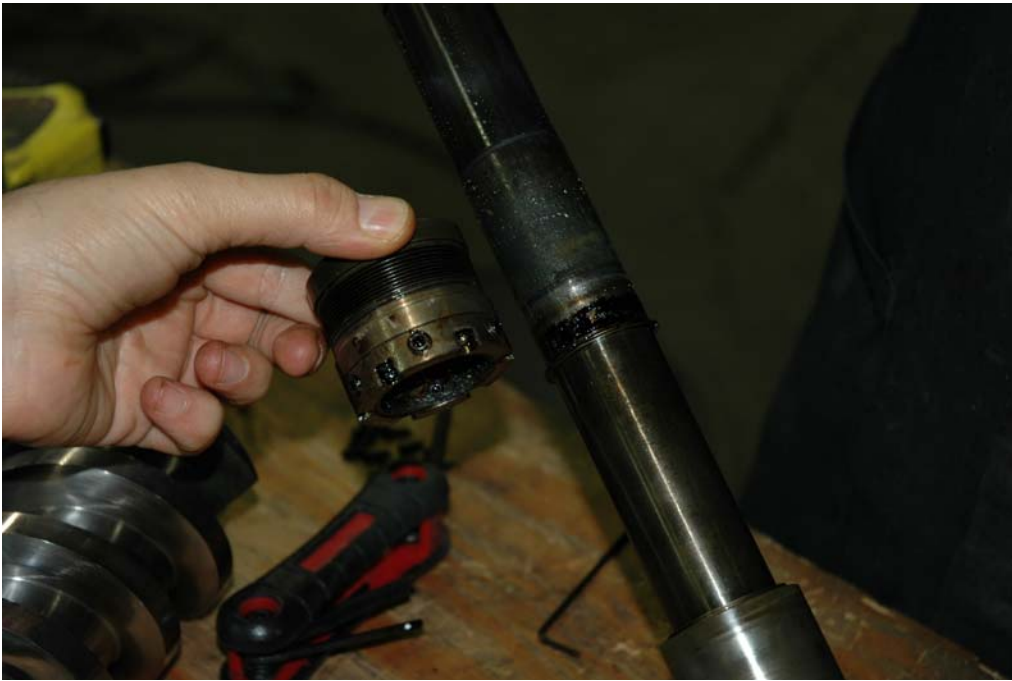
removed from the housing was completely deformed and appeared to be damaged or lost its properties.

Mechanical Seal removed from the intake shaft

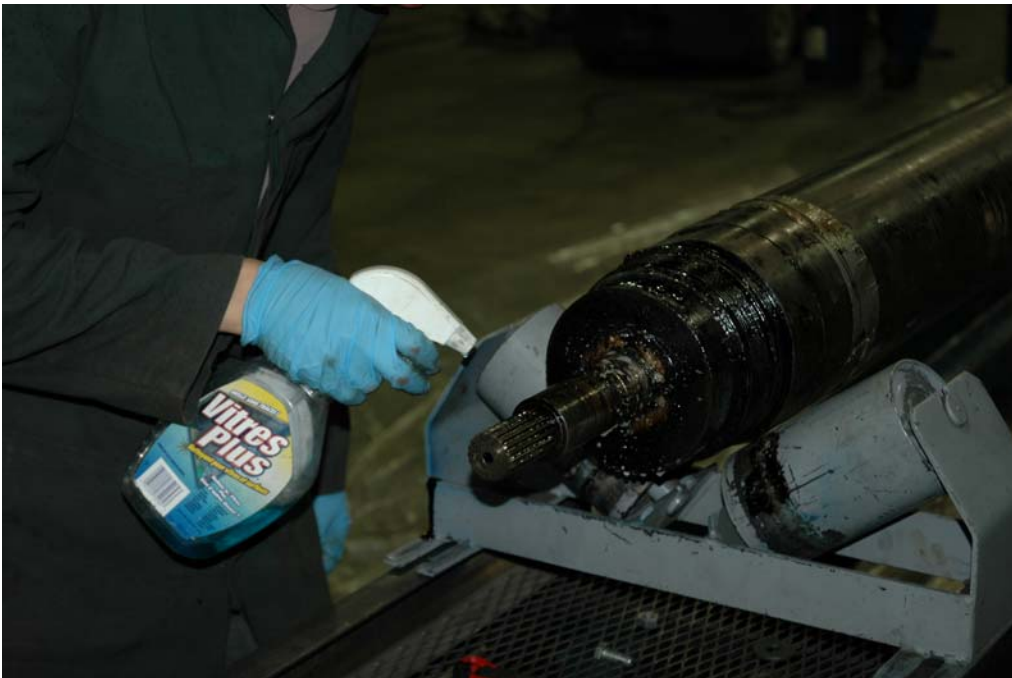
Bottom Mechanical seal tested for leaks under pressure.

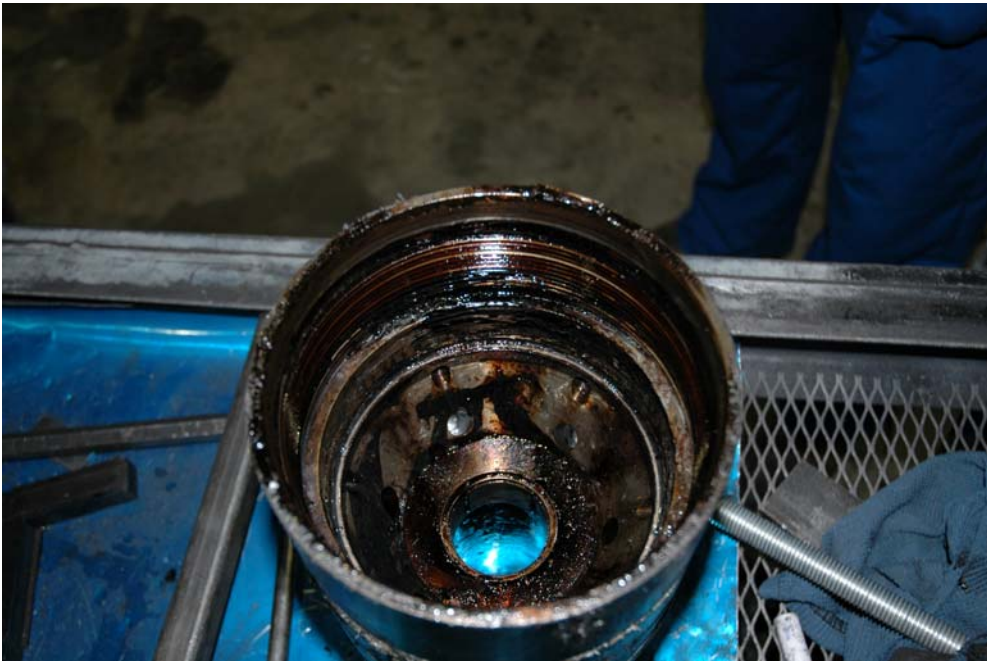
Bottom flange section (this is the section that connects to the Schlumberger's protector) removed to expose the mechanical seals.
